F-4C/D LIFE EXTENSION PROGRAM

Robert L. Schneider
Structures Test Branch
Structures and Dynamics Division

October 1982

Final Report for Period October 1974 - May 1981

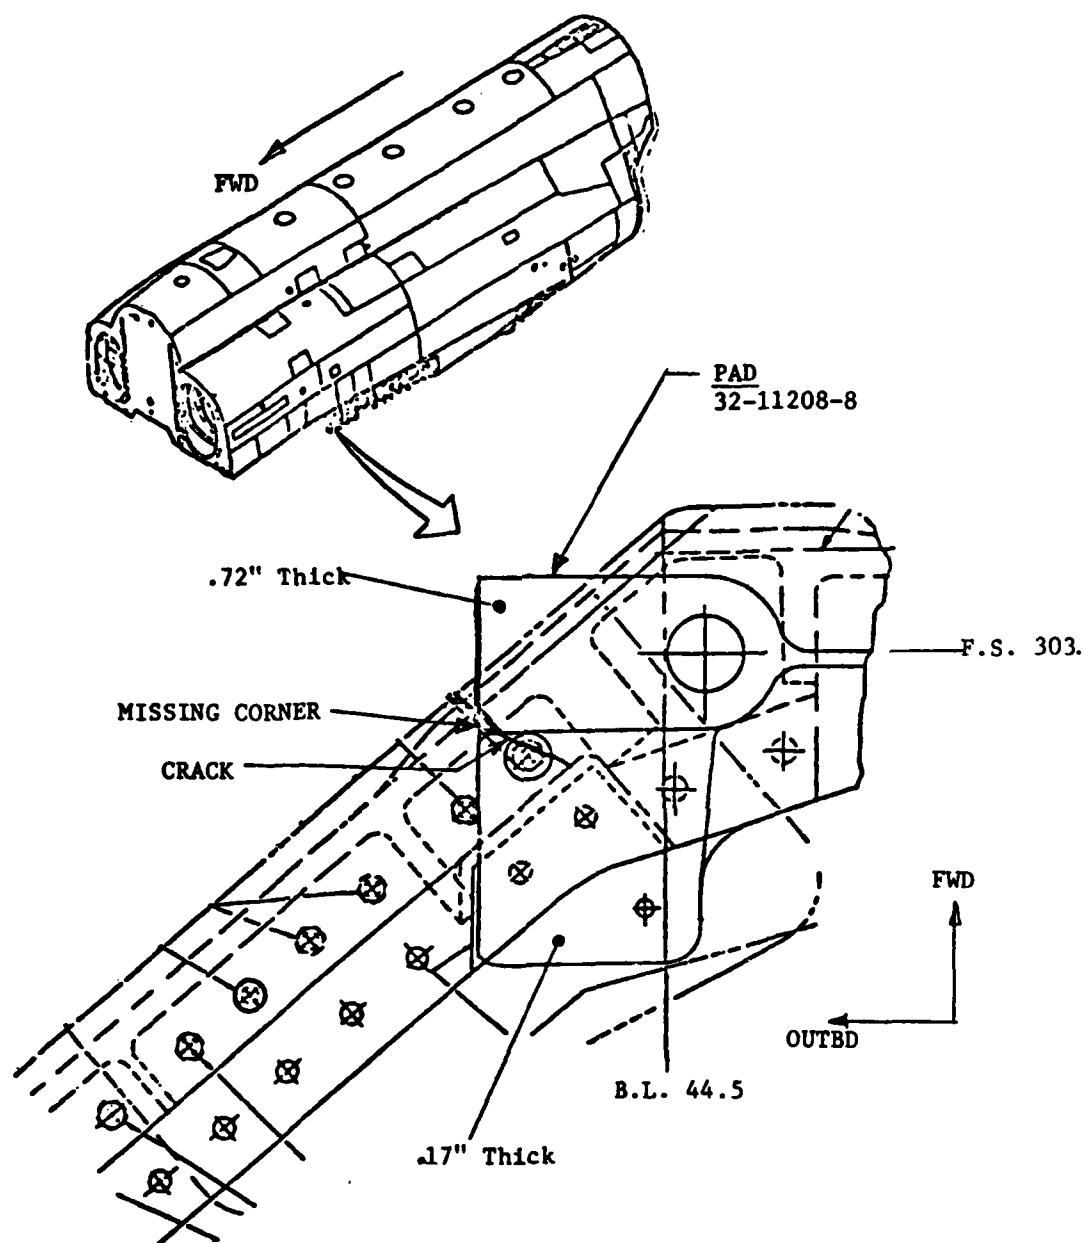
Figure 48. Crack in Pad between Torque Box and 303 Bulkhead
